Inspection of works, 14-17 Moore St.

15th December 2016

An inspection of the ongoing Essential Works being carried out at 14-17 Moore St. and as approved by the High Court, was undertaken on 15th December 2016.

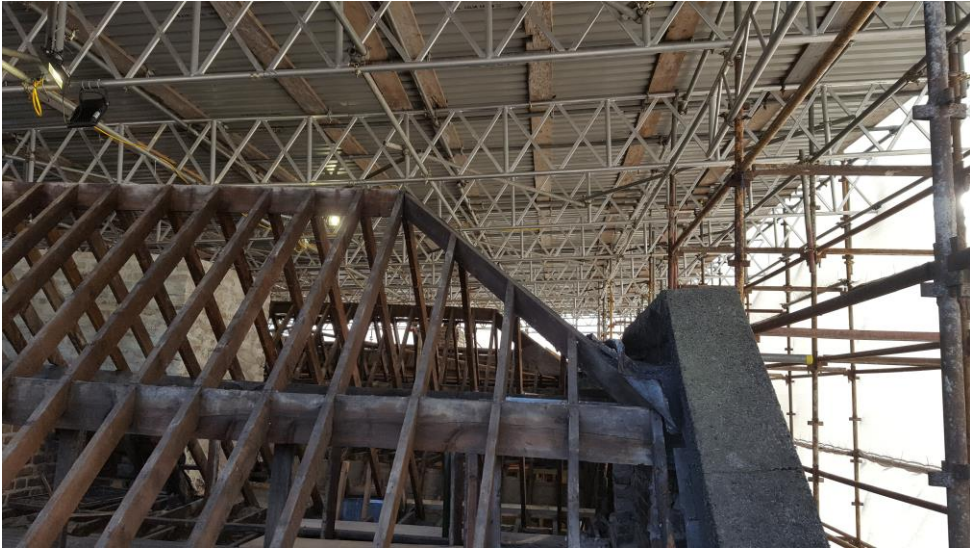
Rafters exposed with over-roof in place (Photo: J. Donnelly)

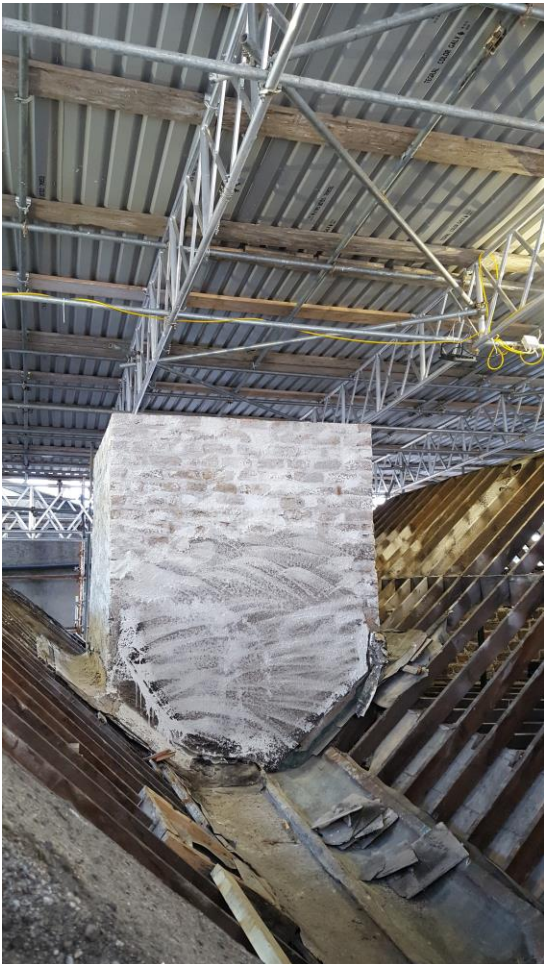
Repaired chimneybreast before application of render (Photo: J. Donnelly)

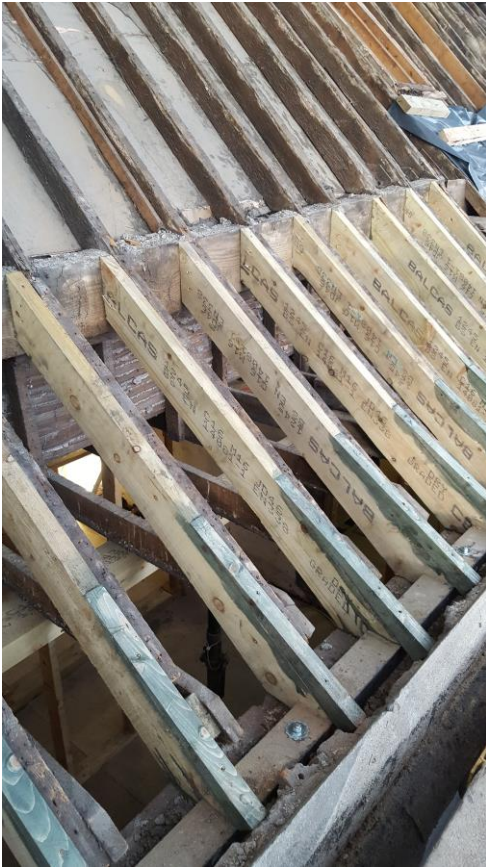
The main focus of the work is on the repair of the roofs of nos. 14-17. All chimney stacks have now been repaired. The ends of purlins that were decayed are being repaired and steel sleeves are being used where required, to affix them to the masonry facades. The rafters are being systematically repaired and companion rafters are being inserted where necessary for additional support, particularly where rafter ends were decayed. The final engineering solutions to the structural defects at the back of the buildings in particular, are being resolved by the design team. This may require the insertion of a steel beam to support the upper part of the rear wall of No.17 at which stage the necessary steel works will be ordered. These works are likely to cause an extension to the programme. It now seems likely that very little, if any dismantling of the front parapets will be needed.

Companion rafters in place (Photo: J. Donnelly)

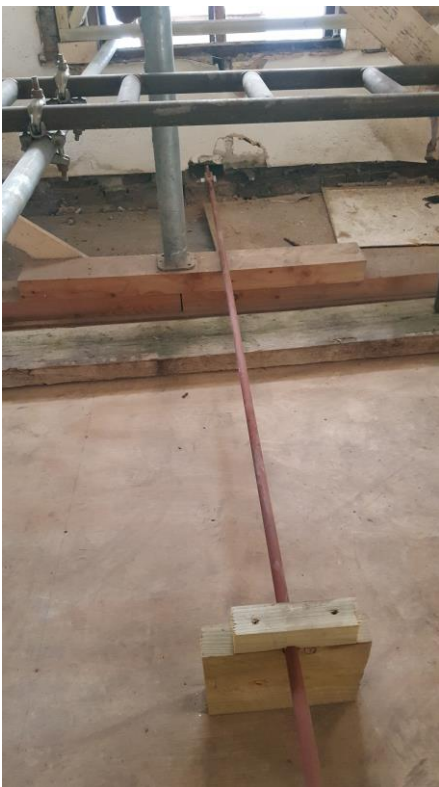
The temporary tie bars to support the facades have been installed pending the final reinstatement of the floors. This has involved the removal of individual bricks which have been retained for later reinstatement.

Internal steel tie (Photo: J. Donnelly)

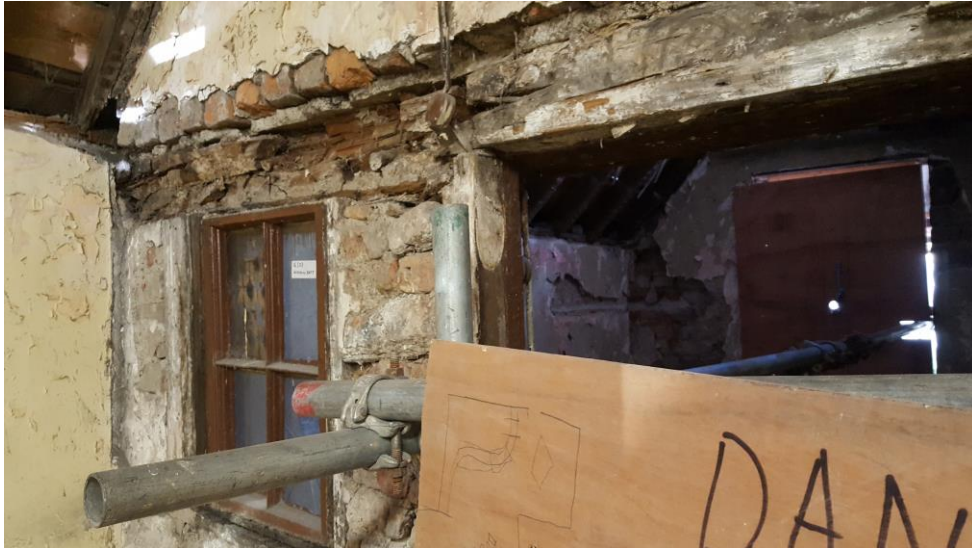
Decayed timber lintel in internal partition wall (Photo: J. Donnelly)

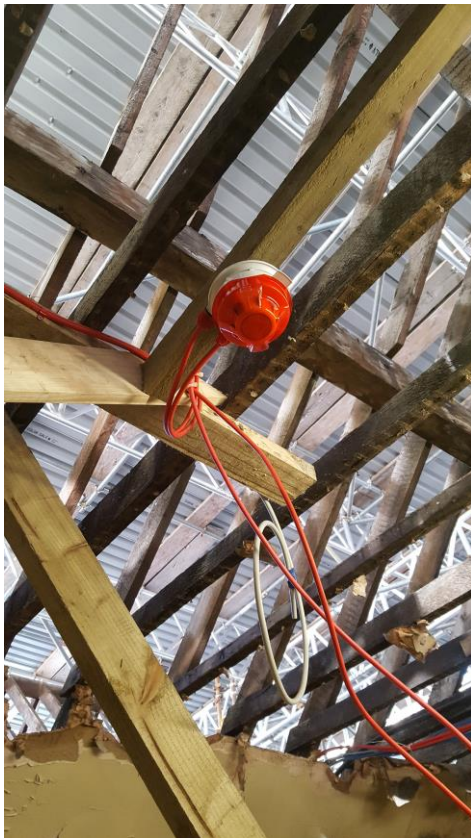
The second fix of the temporary electrics is underway.

Fixing of temporary electrics (Photo: J. Donnelly)
